# Kitsap Conservation District

Tree Sale Edition

## A Better Home for Salmon

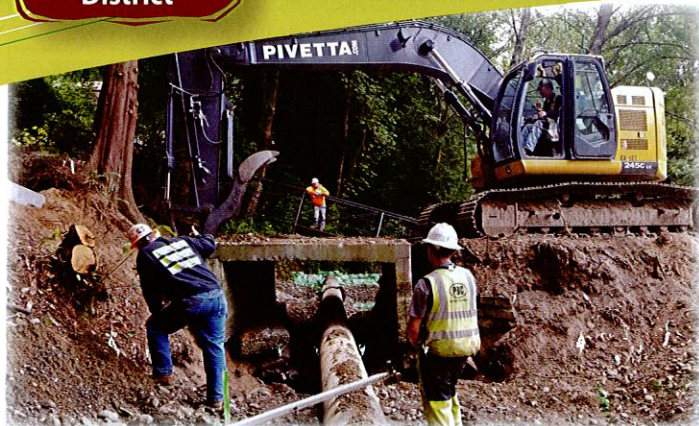
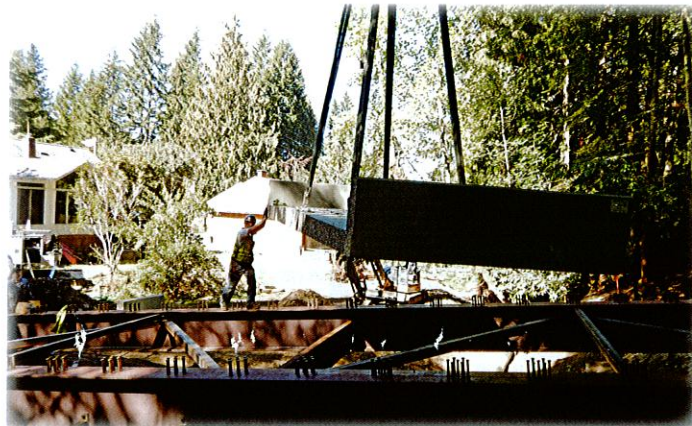
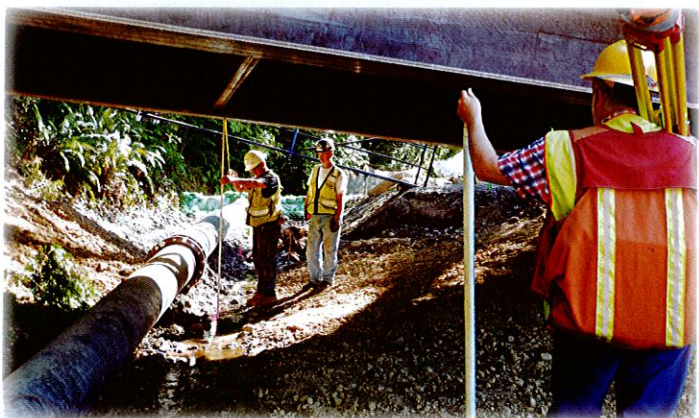
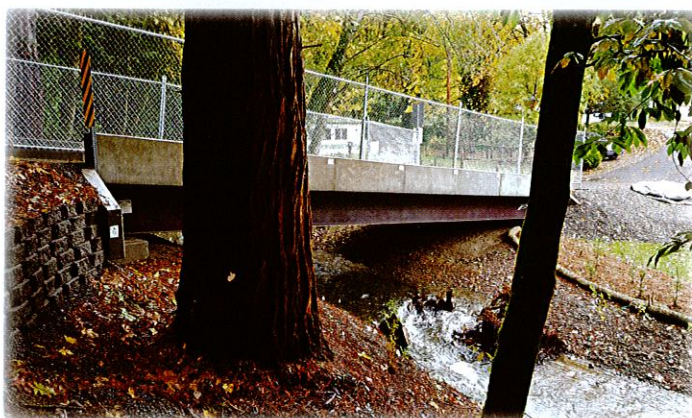
The culvert at this site in the Chico Watershed was undersized and failing. In addition, it blocked salmon passage. The Chico Watershed Assessment identified this culvert as a high priority for replacement, so Kitsap Conservation District staff contacted the landowner to offer assistance. Kitsap Conservation District and the Family Forest Fish Passage Program replaced the culvert with a concrete bridge that can accommodate heavy rains and enable salmon to pass through to a spawning and rearing area in upper Kitsap Creek.

The first step of the project was removing the concrete and tires that were armoring the bank, and replacing them with habitat logs. Installation of these logs created scour pools and areas of slow moving water. The habitat logs also sorted stream bed material and spawning gravels. Noxious weeds (English Ivy and Himalayan blackberry) were removed, and the area was replanted with native trees and shrubs. The real heavy lifting started with assembly of the new bridge. Concrete bridge deck panels were lifted using a crane.
